CONNECTICUT RIVER BASIN
SOUTH HADLEY, MASSACHUSETTS

HILLSIDE BEACH
MA 00600

PHASE I INSPECTION REPORT
NATIONAL DAM INSPECTION PROGRAM

JUNE 1979

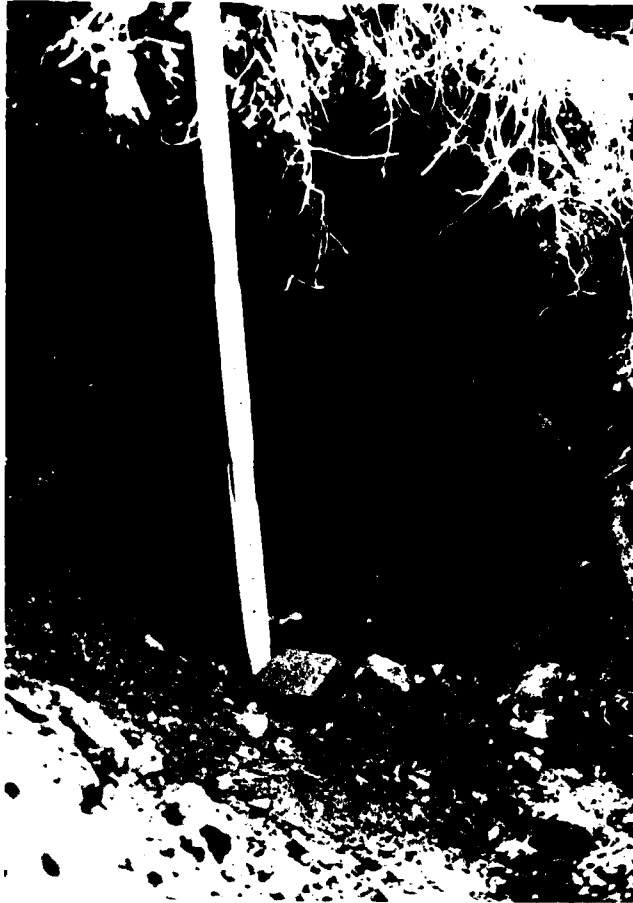
up view of the hole is shown in photograph 3. Bricks were observed to the bottom of the hole which was about 1.5 feet deep. The actual depth of fill is unknown.

PHOTO NO. 3 - Close-up view of test hole made
in brick rubble fill to right of right spillway
chute wall; See PHOTO NO. 4

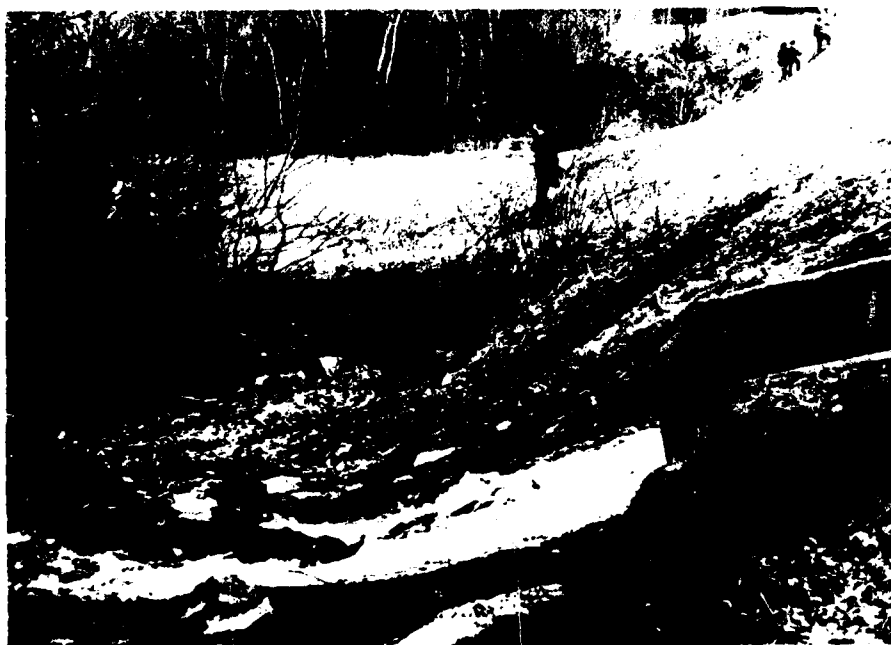
The portion of the embankment immediately downstream of the spillway discharge channel has been eroded as shown in photograph 6. This condition is discussed in more detail in

Severe erosion of the embankment, in the immediate vicinity of the spillway discharge channel, has occurred. This erosion continues to the toe of the dam. This eroded area is covered with a loose dumped fill containing bricks and has numerous voids. Seepage from this eroded area was observed.

PHOTO NO. 6 - View of eroded embankment to the right of the spillway chute; erosion of embankment toe has occurred.

The findings of the visual inspection indicate that the owner should engage a qualified engineer to design appropriate corrective measures to: 1) repair the eroded embankment adjacent to the spillway discharge channel, 2) repair the eroded downstream toe of the dam at the left end, 3) repair the eroded left bank area downstream of the spillway, 4) repair the eroded upstream slope and, 5) prevent future erosion of the areas described in 1 through

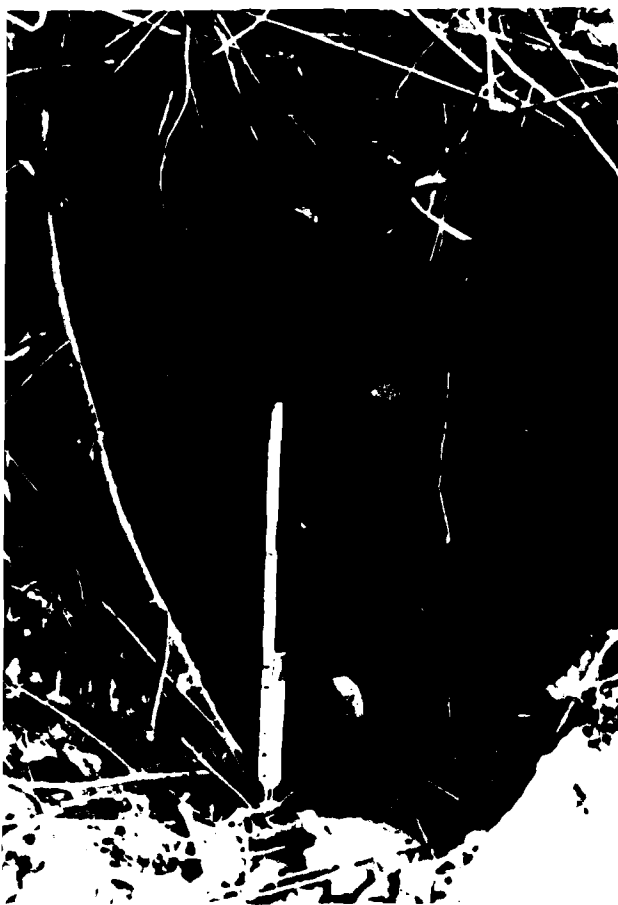
PHOTO NO. 8 - One of several
voids observed in eroded area
of embankment to right of the
spillway; stick was pushed
into void about 20 inches.
Water was seen at the bottom
of the void.
